SEYMOUR HOME INSPECTIONS

1736 Perch San Pedro, CA 90732

Inspection Date:

08/27/2010

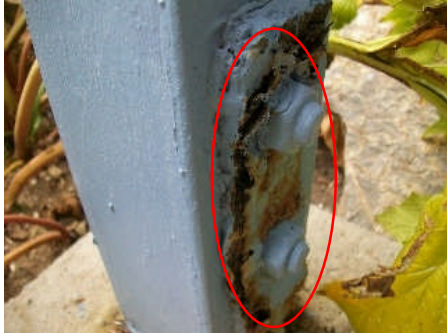
Deck support pier bracket is rusting out

- Deck support post metal bracket is rusting recommend replacing bracket and painting.
- Garden retaining wall in front yard has failed recommend licensed contractor to make repairs.

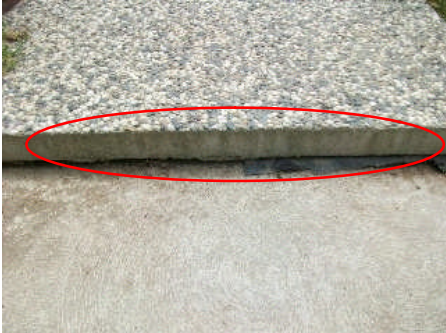
Concrete walk way has trip hazard

- Driveway and side walk have settling cracks and trip hazard recommend licensed contractor make repairs.
- Deck support post metal bracket is rusting recommend replacing bracket and painting.
- Garden retaining wall in front yard has failed recommend licensed contractor to make repairs.
- East side of house wood and fabric sun shade has reached the end of its useful life recommend removing.
- If going to keep fish pond home owner needs to comply with swimming pool requirements by adding self closing spring to front gate.

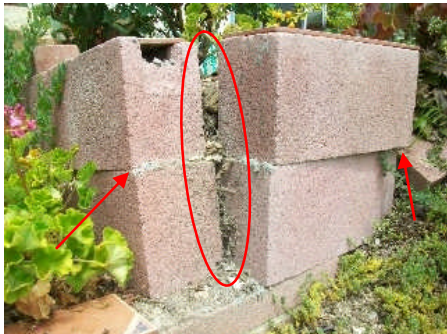
Garden retaining wall in front yard failing

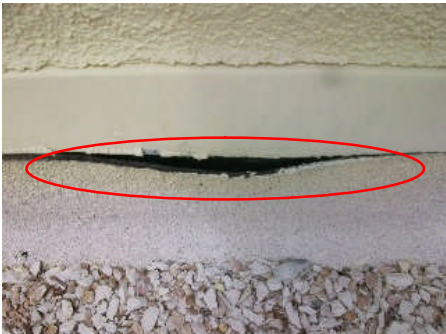
On roof next to balcony tar paper is separating from flashing

- East side of house wood and fabric sun shade has reached the end of its useful life recommend removing.
- On roof tar paper is separating from roof flashing next to balcony recommend licensed roofer make repairs.

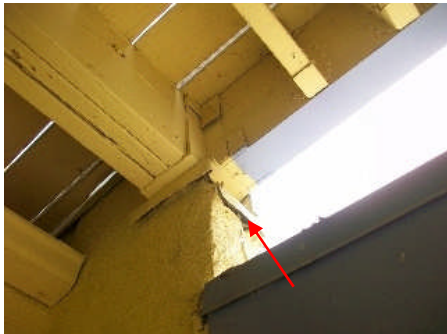
Under balcony hole next to flashing needs To be filled and sealed

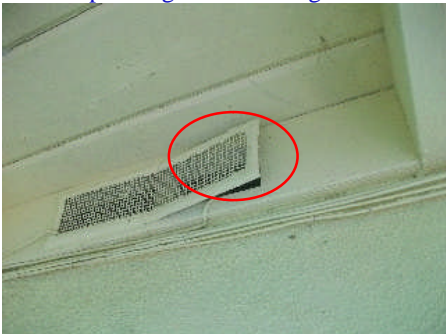
Attic vent needs to be sealed

- On garage roof tar paper is starting to lift and separate also evidence of Ponding recommend licensed Plummer make repairs.
- Attic ventilation screen is damaged and needs to be sealed on east side of house.

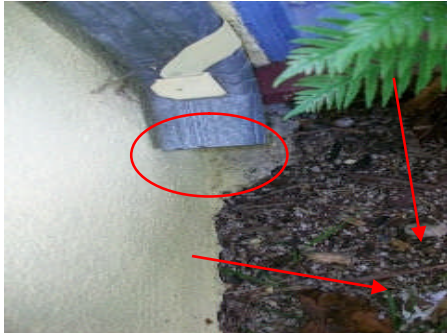
Gutter down spout should discharge
Away from foundation

- Next to front door gutter down spout needs extension so the water is discharged away from foundation.
- Front door sticks when you try to open door recommend repairing.

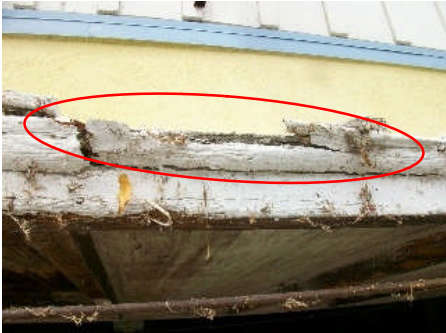
Garage weather stripping needs to be replaced

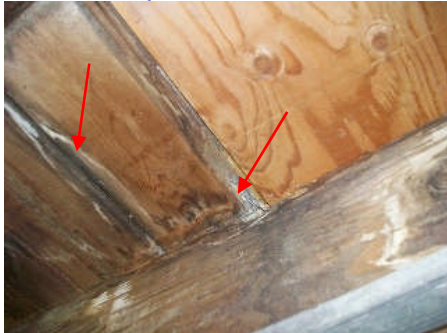
Garage roof has water stains and is leaking

- Garage service door is damaged and does not have proper clearance to over head door hard ware recommend making repairs.
- Garage roof has moisture stains from roof leaks recommend licensed roofer to make repairs.

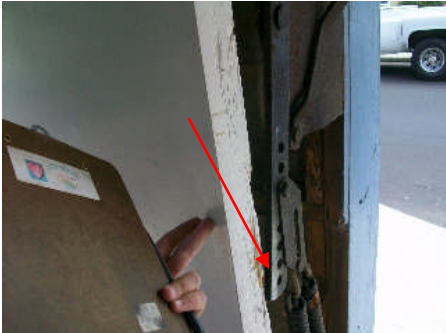
Garage over head door hard ware hits
Garage service door

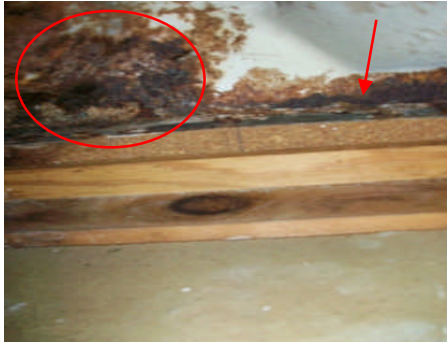
- Under kitchen sink is rusting sink is going to be a deferred cost.
- In kitchen counter top on left side of sink is damaged recommend repairing.
- In kitchen smoke detector is not operating.

Under kitchen sink is rusting

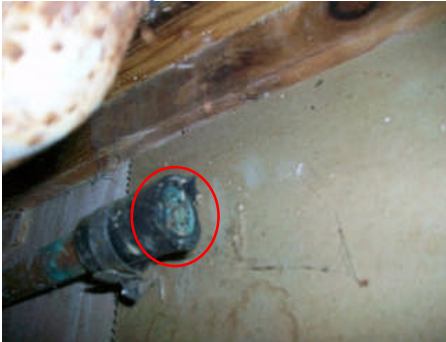
Pipe under kitchen sink needs to be capped

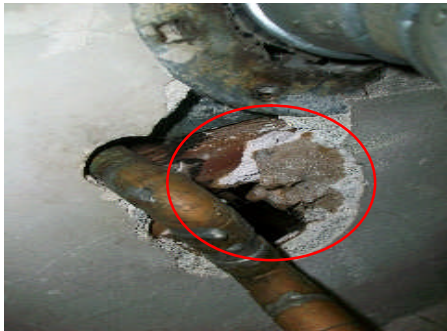
- Water heater is wrapped in insulation so information plate was not visible.
- Water heater closet is missing proper fire separation and proper ventilation recommend licensed contractor make repairs.

Water heater closet has holes around water Pipes need to be filled and sealed

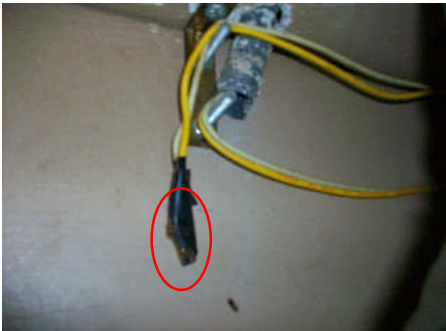
Kitchen hood vent cabinet has some exposed wires

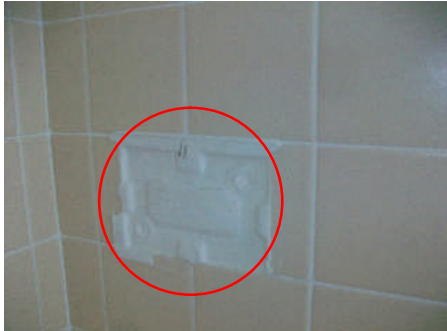
- Upstairs bath under sink drain pipe has leak recommend licensed Plumber to make repair.
- Upstairs bath tile next to shower needs to be re-grouted.
- Upstairs bath soap holder in shower is missing recommend repairing.

Upstairs shower soap shelf is missing

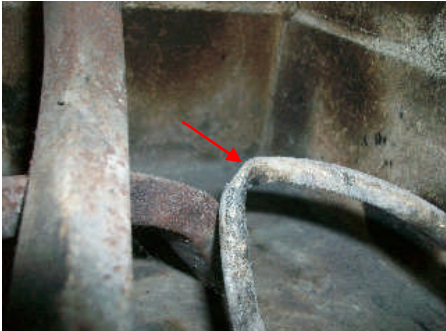
- Dining room fire place gas line is kinked recommend repairing.
- In attic HVAC ducting for upstairs room is crushed recommend licensed HVAC technician repair.
- Attic inspection was limited because of lack of room to move.

Dining room fire place gas line is kinked

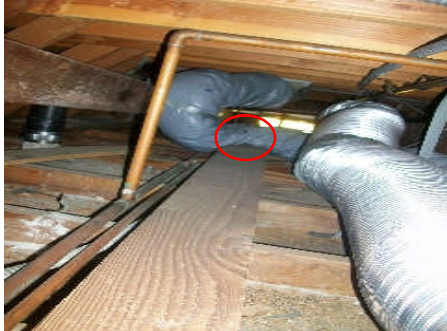
- In attic HVAC ducting for upstairs room is crushed recommend licensed HVAC technician repair.

In attic HVAC ducting is collapsed

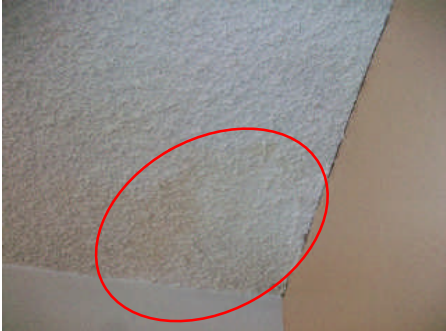
- Living room has moisture stain in N/W corner of ceiling recommend licensed roofer make repairs.
- Living room has several windows that are not safety glass this is a safety hazard recommend repairing.
- Living room wood floors have moisture stain tin S/W corner and floor has several squeaks.

Moisture stain in living room ceiling
